**LOW COST PROCESS FOR MANUFACTURE
OF OXIDE DISPERSION STRENGTHENED (ODS)
TURBINE NOZZLE COMPONENTS.**

General Electric Company
Aircraft Engine Group
Cincinnati, Ohio 45215

(10) J.A. Stahl
R.J. Perkins
P.G. Bailey
December 1979
(11)

(9) TECHNICAL REPORT AFML-TR-79-4163
Final Report for Period 30 June 1976 - 31 December 1979

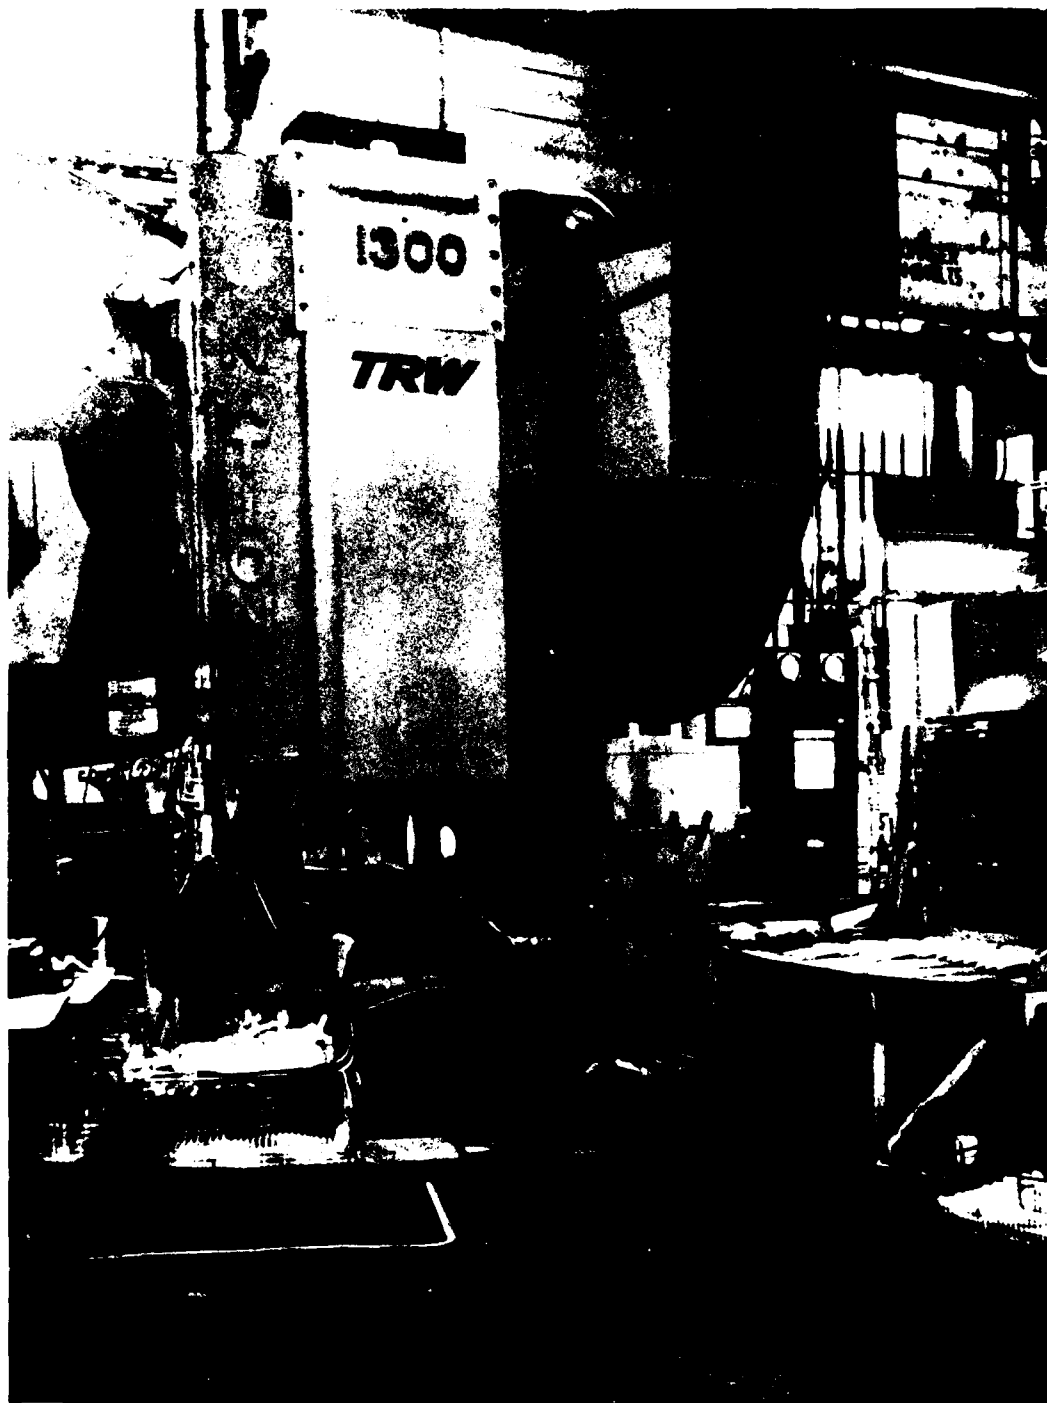
Figure 14. Forge Press Similar to One Used for Directional Forging

Forging trials were conducted at TRW on a 1000 ton mechanical press, photo similar to the one used is shown in Figure 14. The die temperature was maintained at 400°F and the elapsed part transfer time from the furnace to the forging operation averaged 4 to 5 seconds.

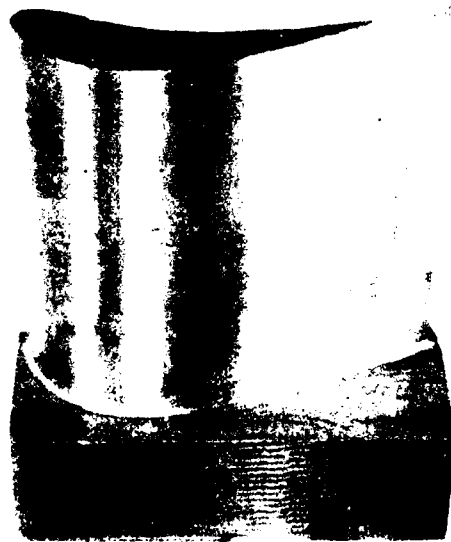
Figure 61. NNS and Partially Machined HPT Vanes

AS FORGED NEAR-NET SHAPE
HPT VANE .040" ENVELOPE

PARTIALLY MACHINED HPT
VANE FROM CONVENTIONAL
RECTANGULAR MA754 BAR

This bottom machined surface then becomes the locating reference for the contour milling operation. If the locating angle is incorrect, too much material could be removed from one side of the vane resulting in a narrow chord width. Once the reference surface was correctly machined the NNS vanes were processed in the same manner as a conventional MA754 HPT vane except that material removed and machining times were less. Figure 61
